Selected AMLU Abandoned Mine Remediation Projects (2007)

Calico District Closures, San Bernardino County, October 2007

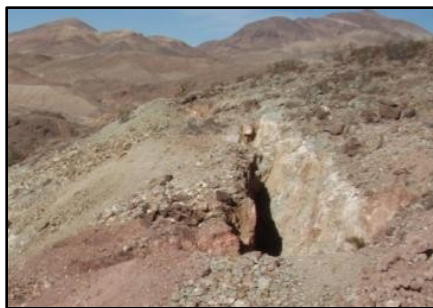
BEFORE

In October 2007, the AMLU and the California State Lands Commission backfilled 13 abandoned mine features in San Bernardino County that ranged from 20 to more than 100 feet deep. Six features were located near the Calico Ghost Town outside Barstow. The Calico District contains extensive abandoned mine workings, including numerous small shafts, collapses, and underground voids waiting to collapse. In 2006, on private property in the same general area, a man was killed after a 50-foot fall down a hidden vertical opening located inside an adit. A week later, a second man was paralyzed after falling into the same opening. One site highlights how some AMLU remediation projects evolve from the initial discovery of the hazard, to temporary fencing, to permanent closure by backfilling.

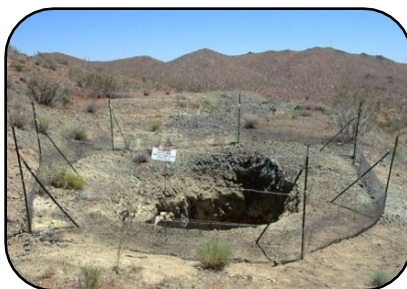
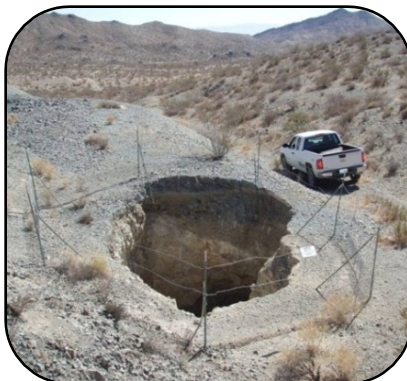
**FENCING (2003) AND
VIEW OF FENCE IN 2007
(note how shaft expanded
and undermined the fence)**

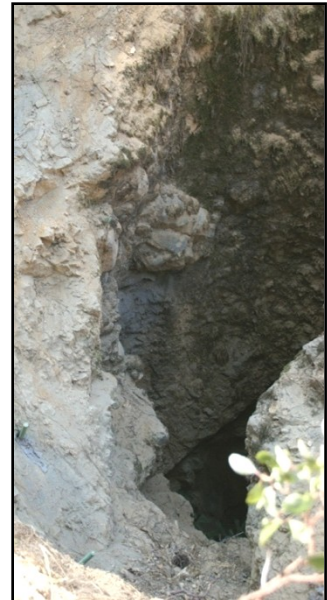
BEFORE

In September 2007, the AMLU helped to close an extremely hazardous feeder shaft and inlet to a drain tunnel for the Le Du hydraulic mine near Malakoff Diggins in Nevada County.

The project had numerous challenges, including mixed ownership, the need to maintain drainage through the features, and the unusually shaped openings. The AMLU worked with the Bureau of Land Management (BLM), and U.S. Forest Service to install high tensile steel mesh over the feeder shaft, which is located on State Parks land, and a similar closure modified with a bat gate on the inlet, which is located on BLM land.

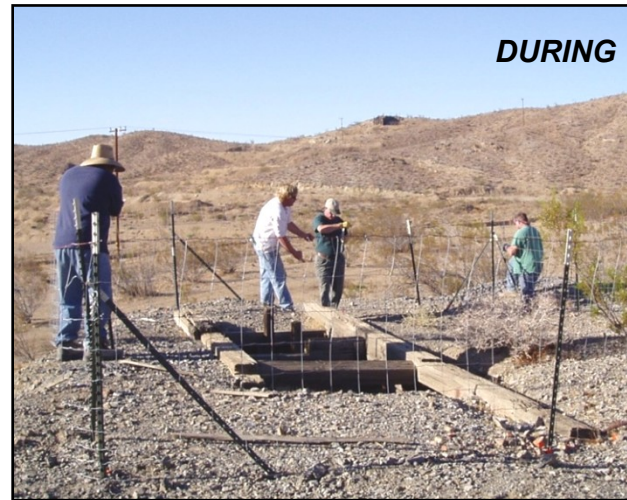
In September 2007, the AMLU partnered with the Ridgecrest Field Office of the Bureau of Land Management (BLM) to fence 42 hazardous features in the Red Mountain Area. Forty of the shafts were located in San Bernardino County and the other two shafts were in Kern County.

The Red Mountain and Randsburg areas contain hundreds of dangerous open mine shafts that pose a serious risk to the general public, including off highway vehicle (OHV) users who recreate on the public land in the area. On December 24, 2006, the Kern County Fire Department responded to a report that a 9-year-old fell down a mine shaft. Fortunately for the family, the boy only suffered minor injuries from the incident. Then in January 2007, another incident at an open mine shaft was reported to the BLM. In this incident, a rider drove onto a tailings pile and nearly fell into the shaft. In 2005, another rider was killed when he drove his motorcycle into a mine shaft located on private land and fell nearly 700 feet. After the December 24, 2006 and January 2007 incidents, the BLM fenced the two shafts. This project enabled the BLM to fence many more shafts in the area that pose a serious threat to the health and safety of the general public.

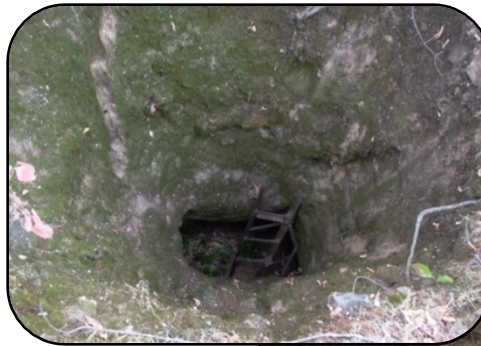
SHAFT (before and during PUF closure (before PUF covered with soil))

In June 2007, the AMLU partnered with the Bakersfield Field Office of the Bureau of Land Management (BLM) to permanently close two abandoned mine shafts and three abandoned mine adits, as well as fill several pits in Madera County.

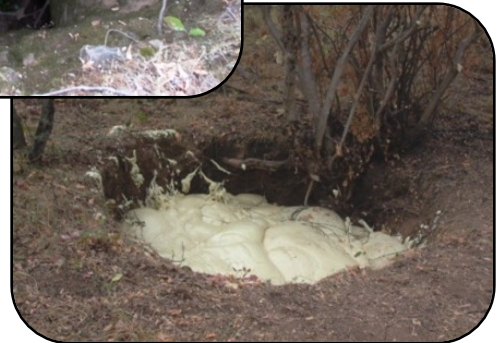
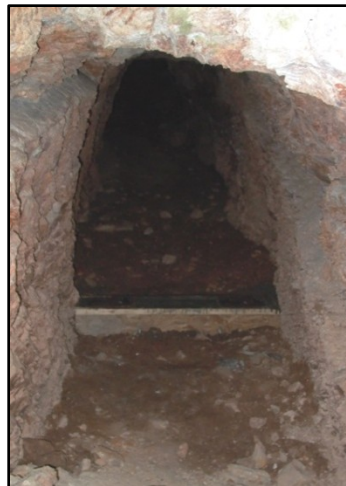
ADIT (before and after bat gate installed)
